# RESTORATION STUDY | 1887 WEST SIXTH STREET BRIDGE AT SHOAL CREEK

**SPARKS ENGINEERING, INC.**  
[www.sparksengineering.com](http://www.sparksengineering.com)

LIMBACHER & GODFREY  
ARCHITECTS

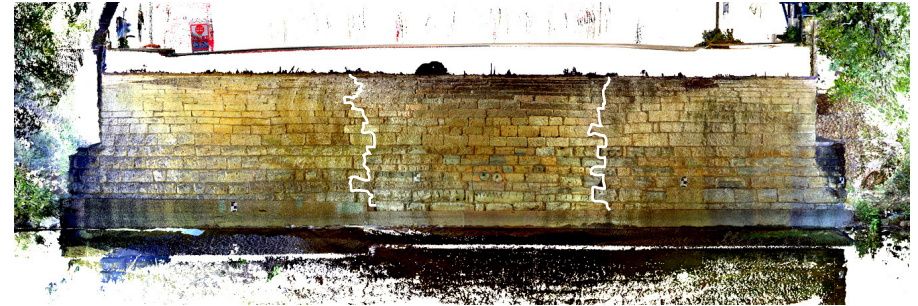
West Sixth Street Bridge, middle vault longitudinal section showing construction joints within the length.

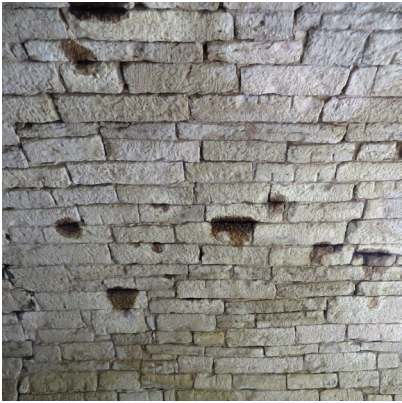
Bat colonies at dark spots

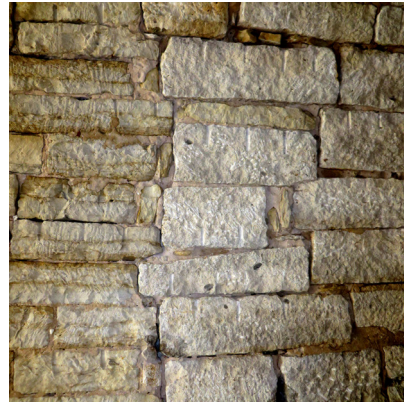
Construction joint  
- change in stone -

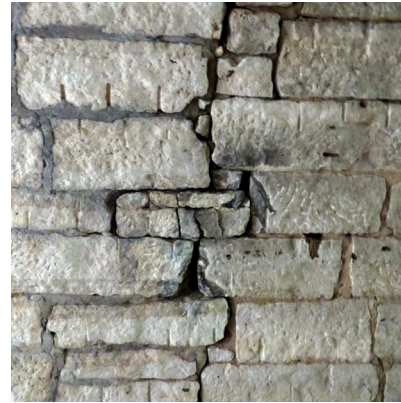
Broken stone / Missing mortar

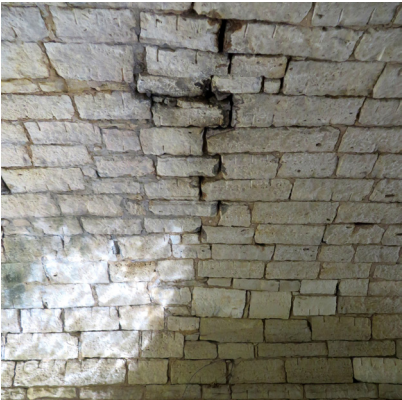
Stone slippage at joint

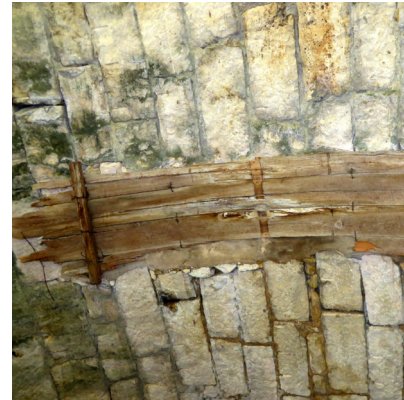
Utilities cut into arch stones

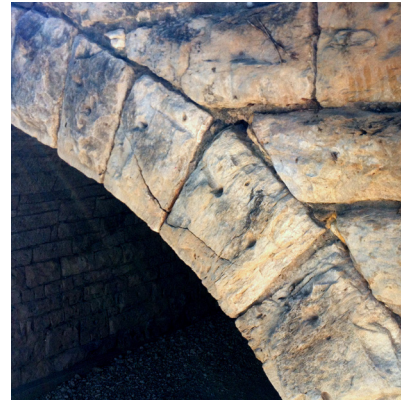
Pinched arch stones

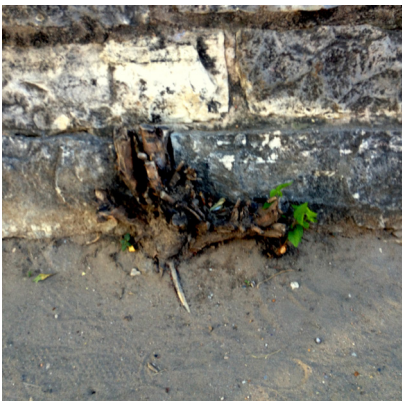
Root intrusion

- The joints of the arch rings are currently being grouted as recommended.
- Repair sanitary sewer leak.
- Remove trees within 50 ft. of the bridge to stop root growth inside the structure.
- Kill all vegetation growing on, or immediately adjacent to the bridge.

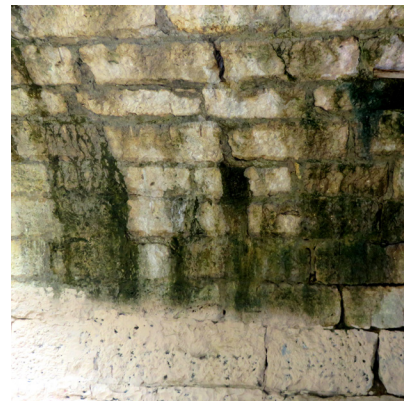
Water infiltration

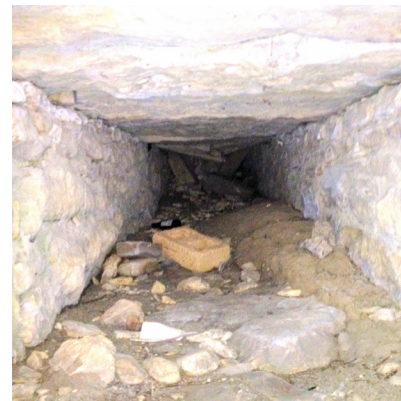
Tunnel collapse, vault A

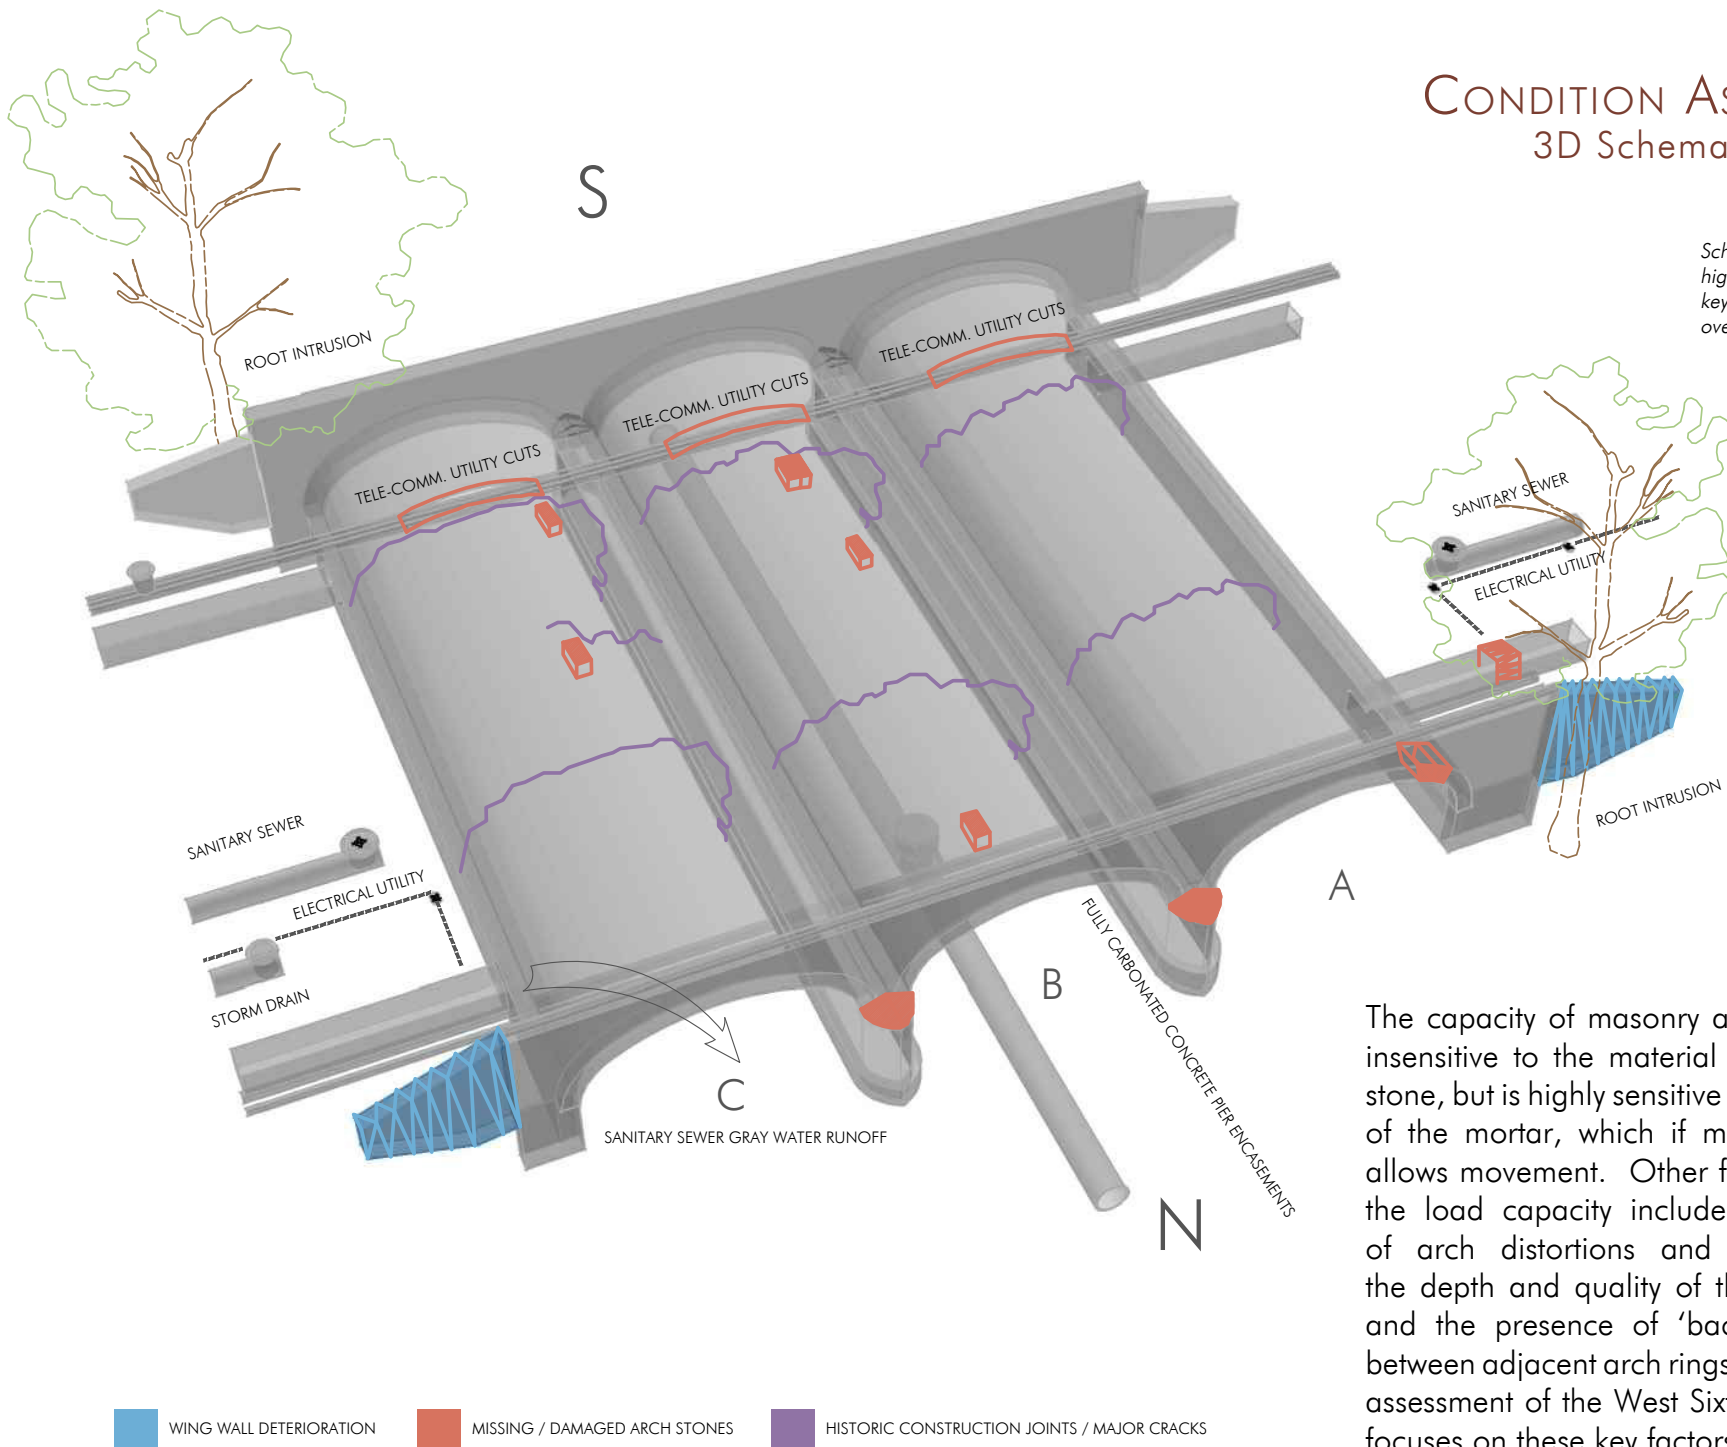
*Schematic Diagram highlighting some of the key factors of the bridges' overall condition.*

The capacity of masonry arches is largely insensitive to the material strength of the stone, but is highly sensitive to the condition of the mortar, which if missing or loose allows movement. Other factors affecting the load capacity include: the presence of arch distortions and discontinuities, the depth and quality of the fill material, and the presence of 'backing' masonry between adjacent arch rings. The condition assessment of the West Sixth Street Bridge focuses on these key factors.

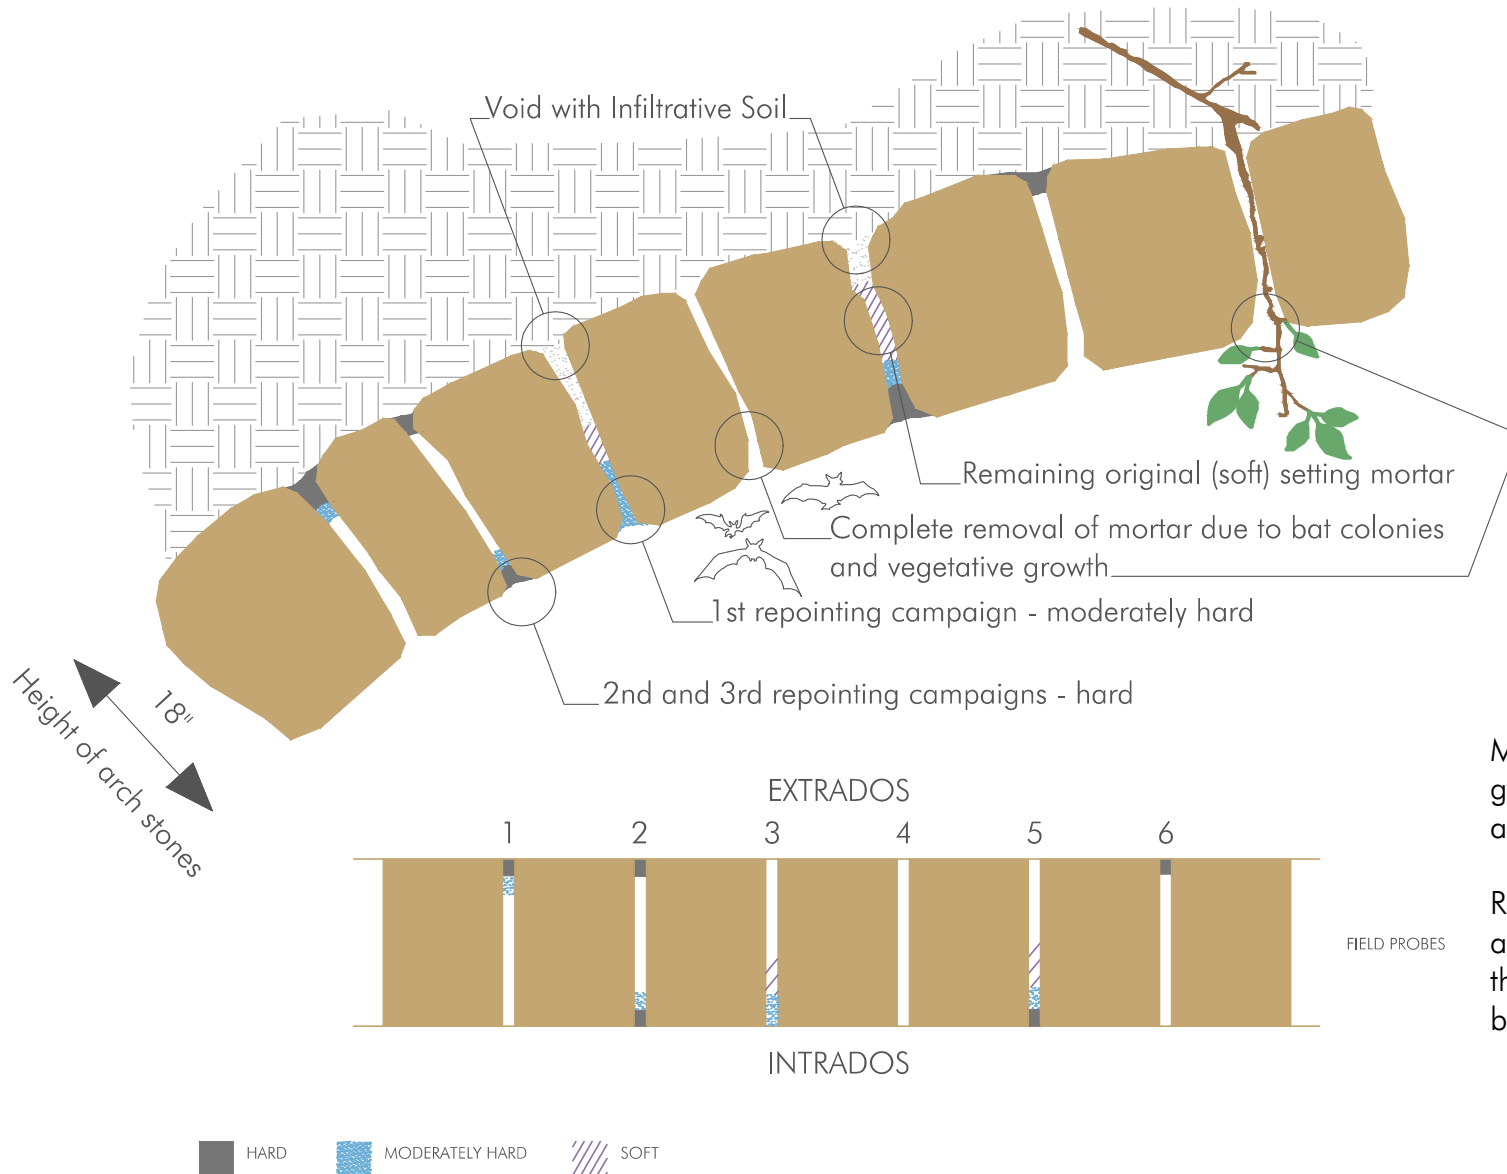
## Mortar Loss Typical Conditions

Mortar loss is significantly greater than previously assumed.

Repointing and grouting are required to recover the load capacity of the bridge.

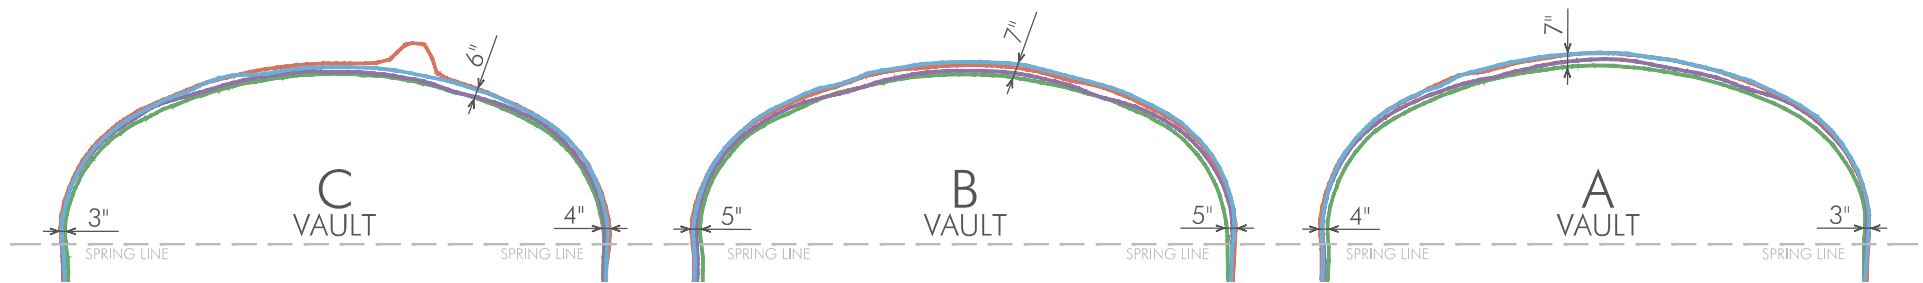
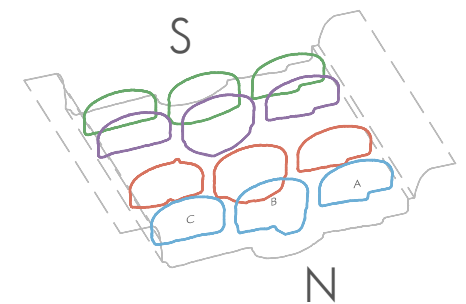
## Barrel Vault Ring Distortion

*The shape of the barrel vaults varies as much as 7" in rise and 10" in span. The highest arch distortion occurs at the utility cuts in the top of the vaults to the south.*

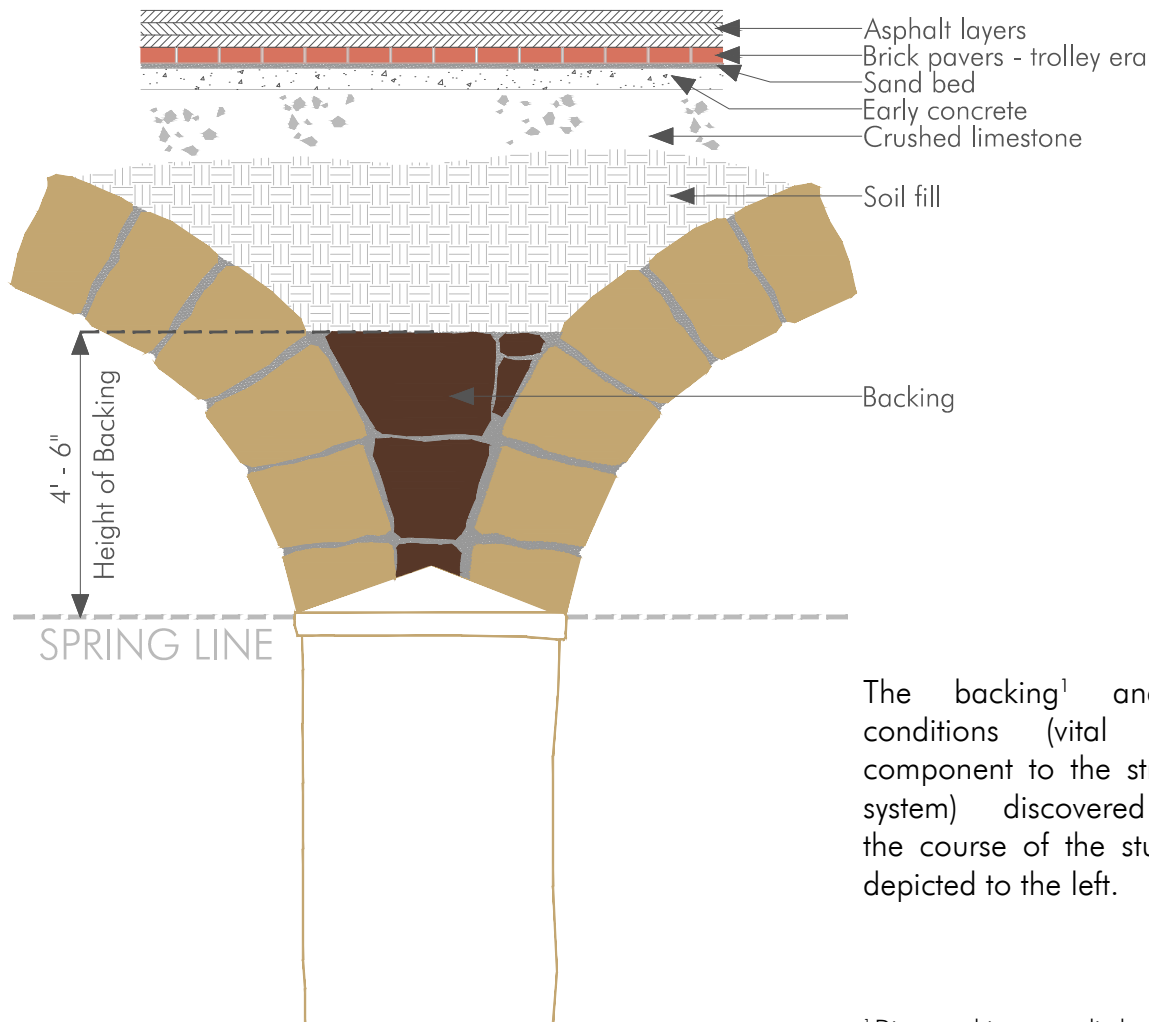
## Backing and Fill Conditions

The backing<sup>1</sup> and fill<sup>2</sup> conditions (vital as a component to the structural system) discovered over the course of the study are depicted to the left.
