**Shoal Creek Conservancy
Shoal Creek Debris and Sediment Inventory
15th Street to Lady Bird Lake
Project Summary**

Project No.: 3151-001-01

Date: October 11, 2016

TECHNICAL MEMORANDUM
Shoal Creek Debris and Sediment Inventory
Project Summary

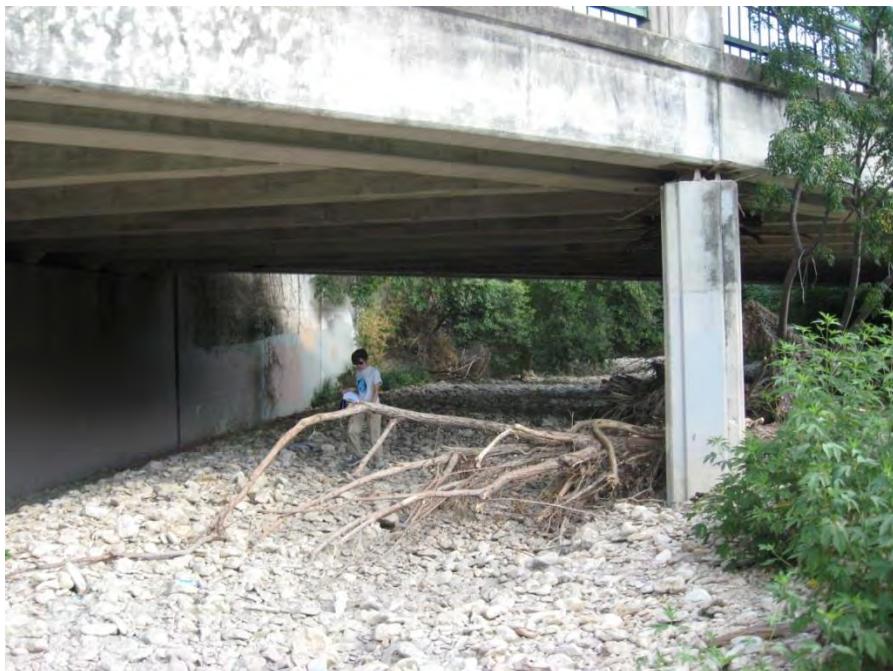
The Lamar Boulevard Bridge should be closely monitored as debris blockage could significantly increase sediment levels and decrease flow conveyance. At the time of the creek walk, there was large woody debris and several small trees growing on the downstream side of the bridge. The woody debris and small trees should be removed to prevent retention of additional debris during high flow events.

Note woody debris and china berry trees at the bridge pier. Suggest removal.

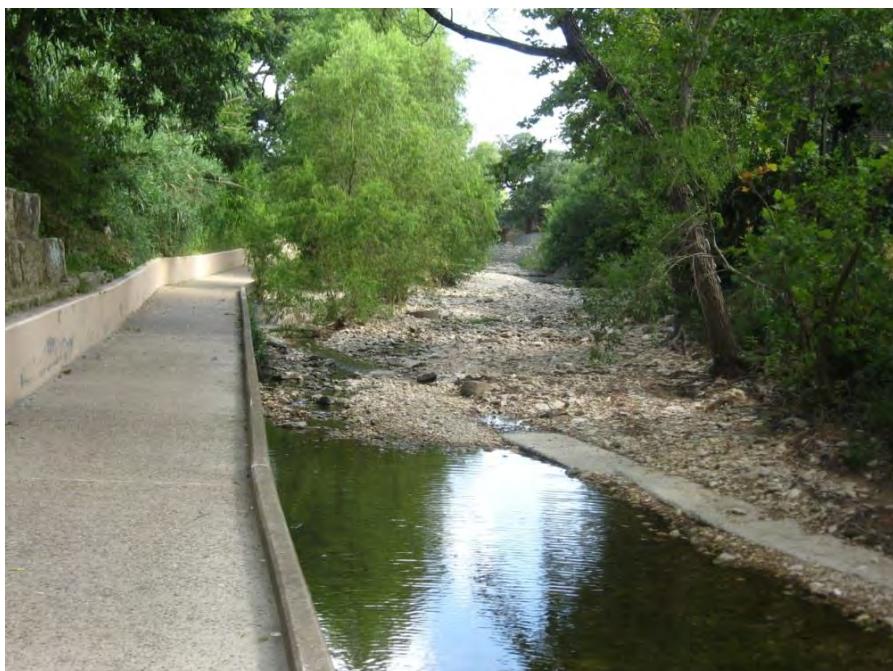
Between 6th and 9th Street, several small willow trees are growing on the creek bottom and adjacent to the hike and bike trail. These trees should be monitored since as they begin to mature they could retain flood debris. The creek is shaded by trees on both creek banks so limited habitat impacts are anticipated if these trees are removed in the future.

Note the willow trees in the channel just to the right of the trail. Monitor tree growth.

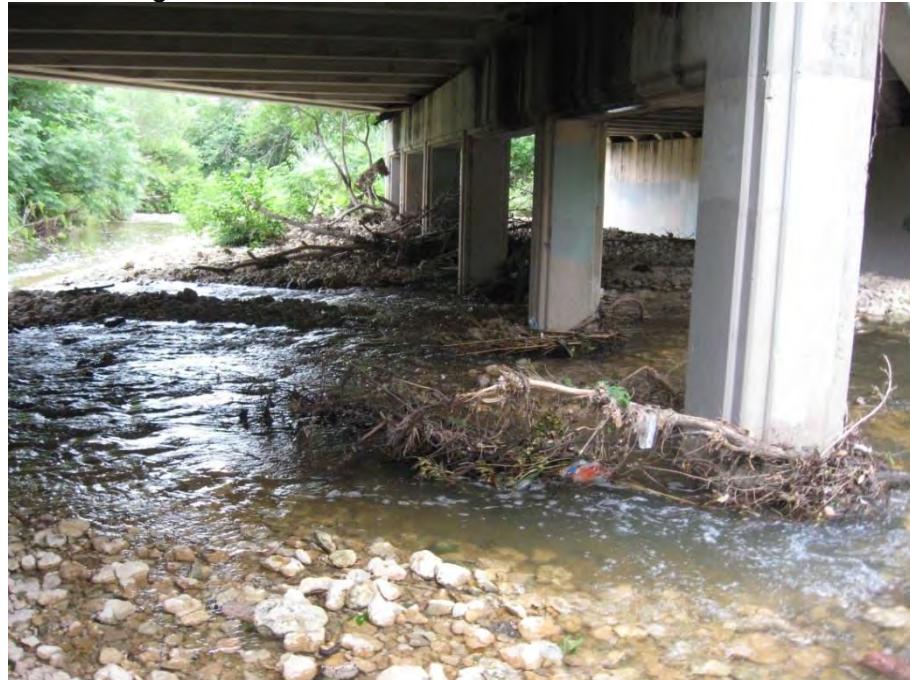
Lamar Bridge

- Lamar: Sediment underneath the bridge, and large sediment sand bar downstream of the bridge.
- 10th Street: Sediment underneath the bridge.
- 9th Street: The pedestrian trail which passes underneath 9th Street creates a significant blockage; however, the removal of the trail is a larger project than the SCC is capable of undertaking. There is also sediment build up underneath 9th Street, but because of the pedestrian trail crossing, the removal of the sediment is unlikely to reduce the flood depth and sediment is likely to be deposited again in the area during the next storm event that causes significant flow in Shoal Creek. There is a large sediment bar downstream of the gabion mat; however, because there is little vegetation on this bar, it is likely recently placed and may migrate with subsequent storm events.

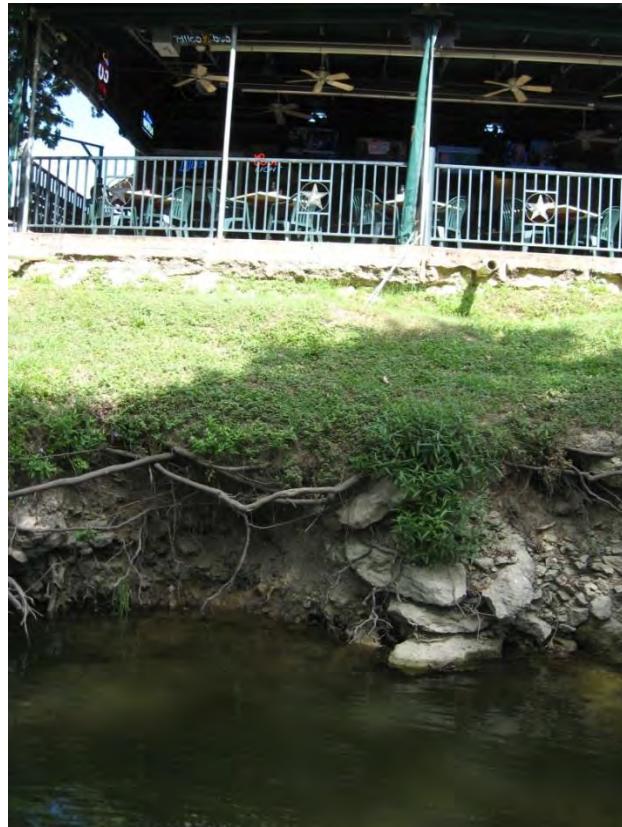
Bank erosion at the Shoal Creek Saloon

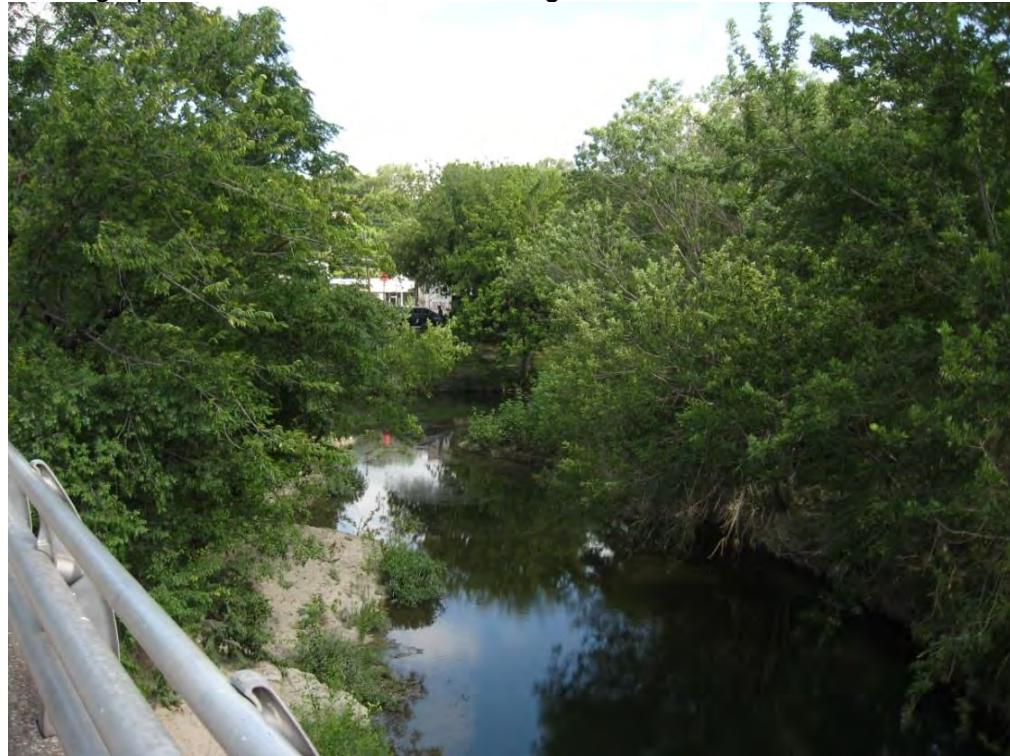
Looking upstream from the 9th Street Bridge

Just upstream at 9th Street, the creek channel turns abruptly to the left and then bends to the right to convey flow below the bridge. These sharp meander bends slow down the creek flow which can cause the water surface elevation to increase. When the stream velocity is reduced, the suspended sediment and gravel can sink to the bottom of the creek and often accumulate on the inside of the bend. This is called the point bar and is common in natural streams where the inside portion of the bend accumulates sediment while the outside bend can erode and widen during the natural evolutionary process of rivers and creeks. The Shoal Creek Erosion Inventory of 1997 includes photographs illustrating the deposition on the point bar just upstream of 9th Street. The same point bar can be found today.

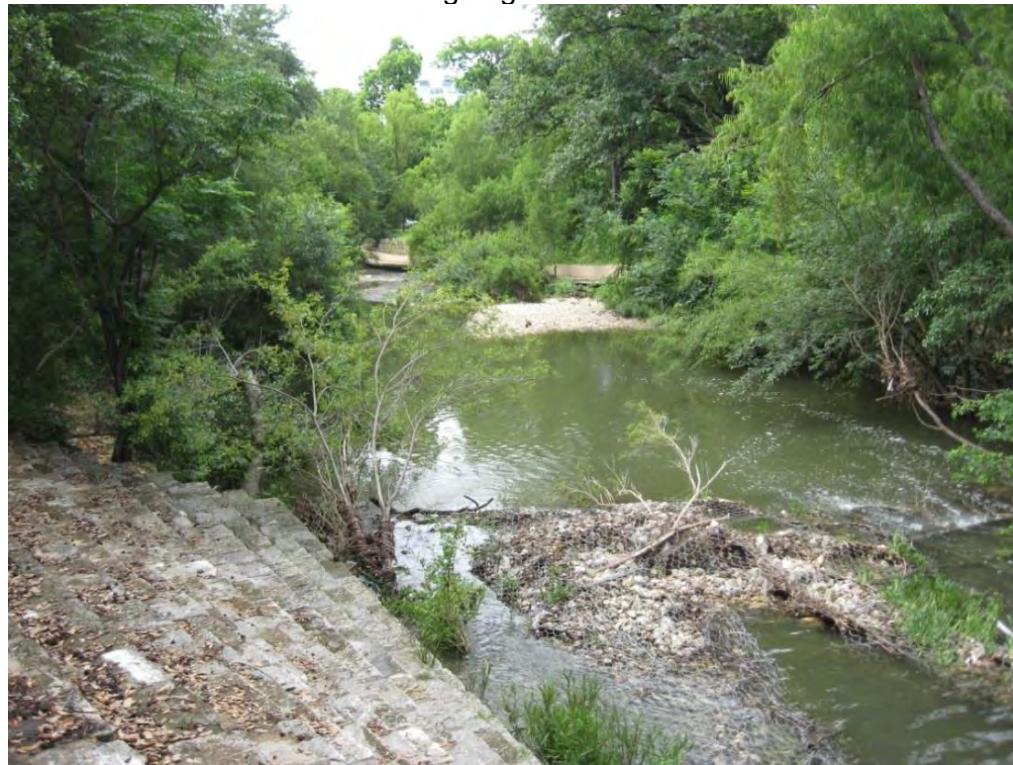
Downstream of 9th Street – Damaged gabion mattress

The PER should also address the gabion mattress downstream of 9th Street that is damaged and needs to be repaired or replaced. This should be done in conjunction with the potential removal of the existing infrastructure beneath the bridge to ensure future channel stability and that the existing pool below 9th Street remains to serve as riparian habitat during dry weather conditions and provide storm flow velocity dissipation.

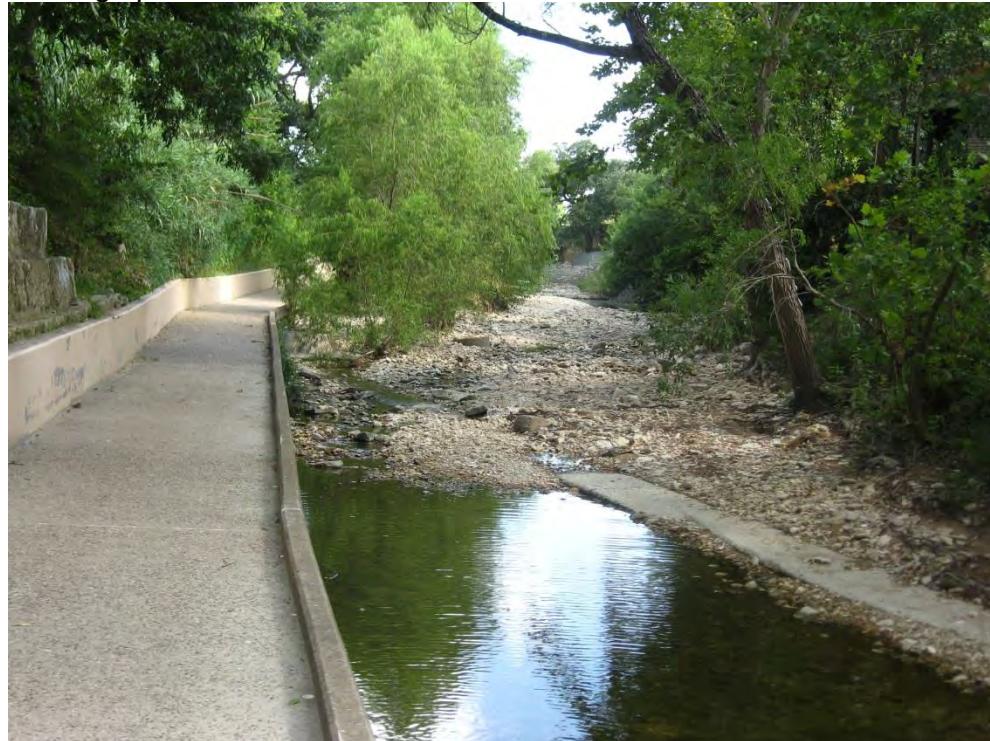
Looking upstream towards 9th Street, note line of willow trees in the channel

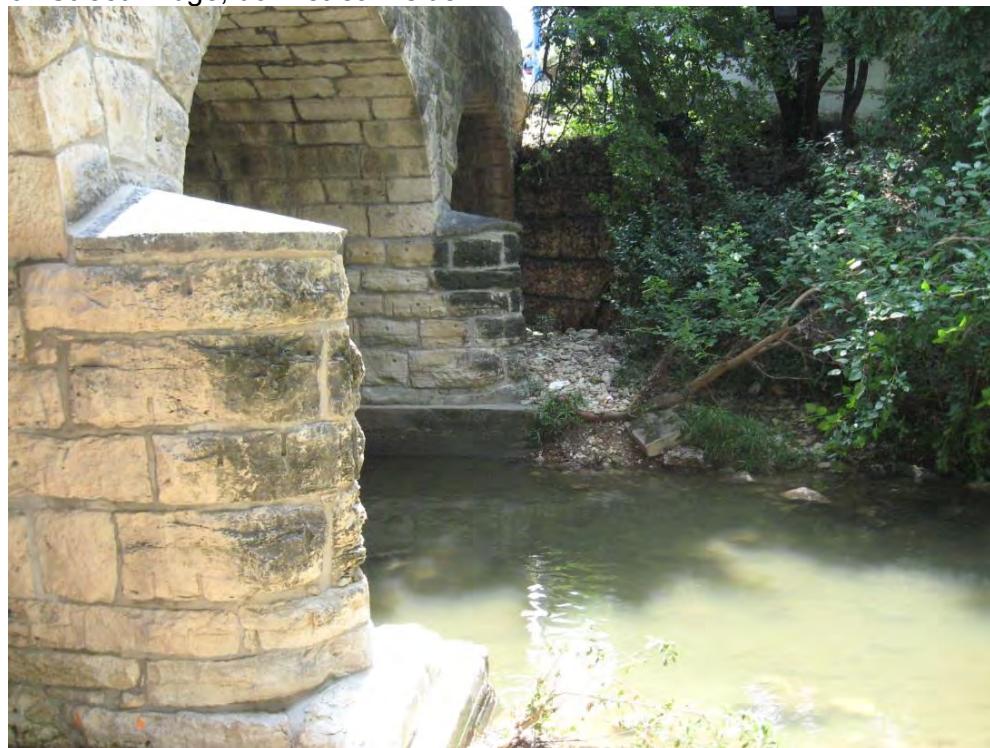
6th Street Bridge, downstream side

- 6th Street: Sediment underneath bridge; especially on the right (west) side adjacent to the pedestrian trail, and on the downstream left (east) side culvert.

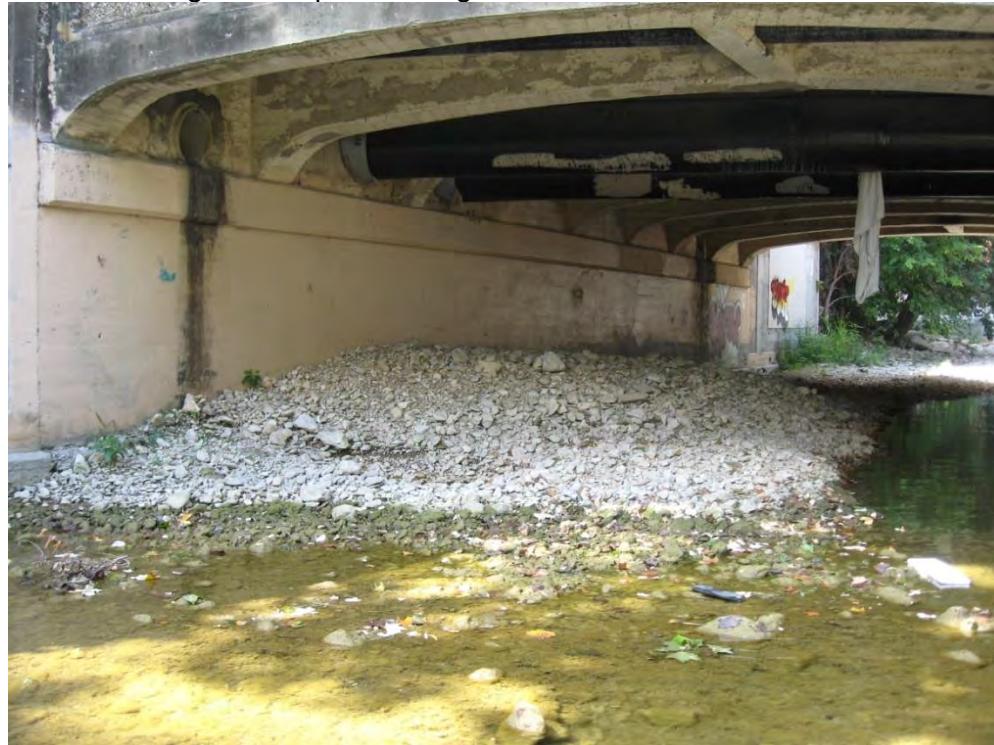
5th Street Bridge, east span, looking downstream

- 5th Street: Sediment underneath the bridge. This area is currently under a maintenance agreement with the Austin City Lofts to perform sediment abatement activities when the sediment is above the footer bump-out on the bridge piers. Currently, there are some areas which are above this elevation and there are areas which are lower. It is very likely that the sediment, if spread out in this immediate area, would be below the point of requiring maintenance.

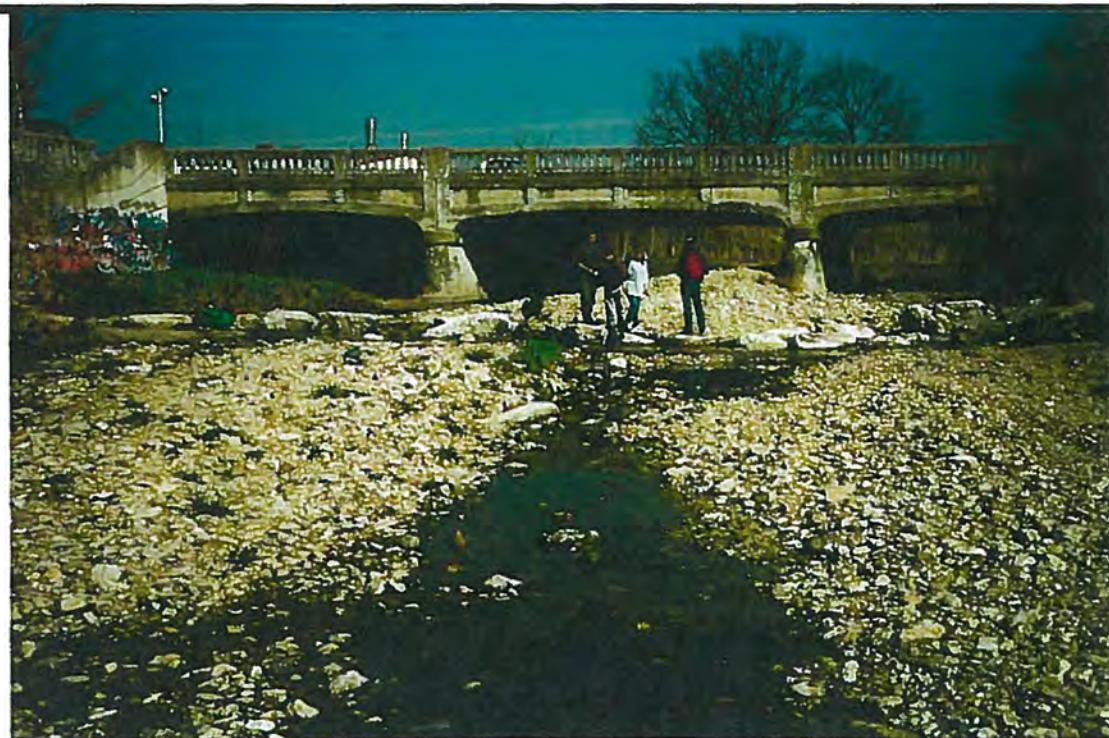
Photo 15. Looking U/S at West 5th Street; island forming in channel and bridge; aggrading section.

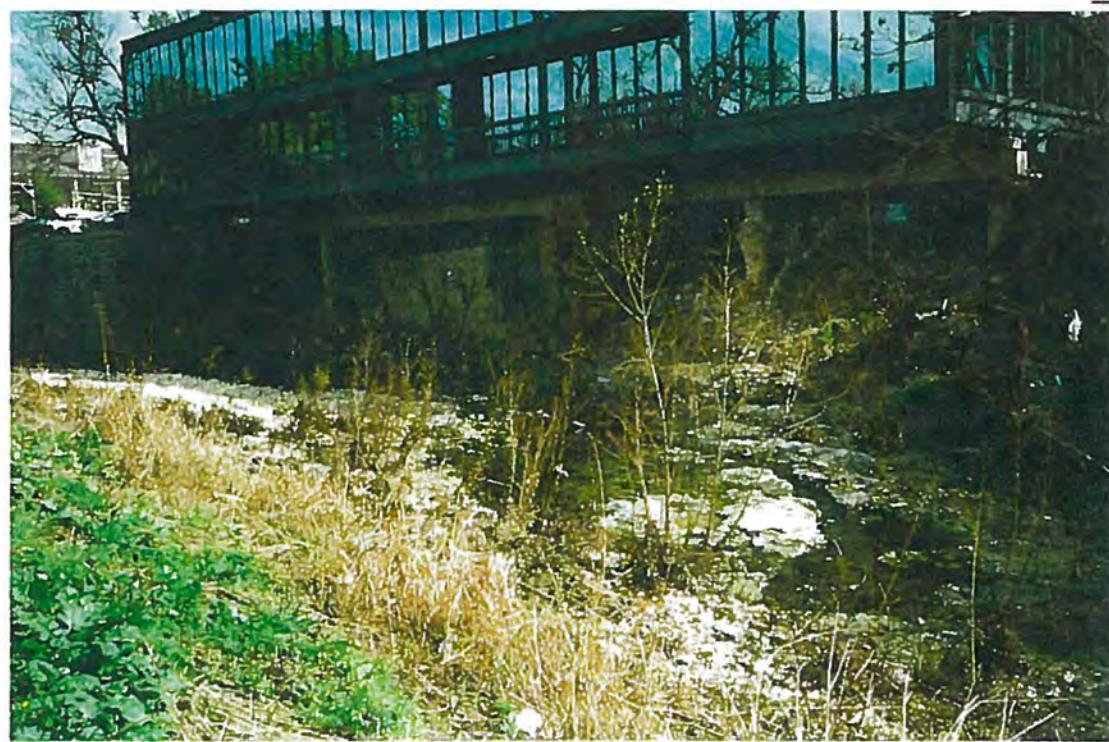
Photo 16. Structure just U/S of 6th Street on right bank with exposed columns.

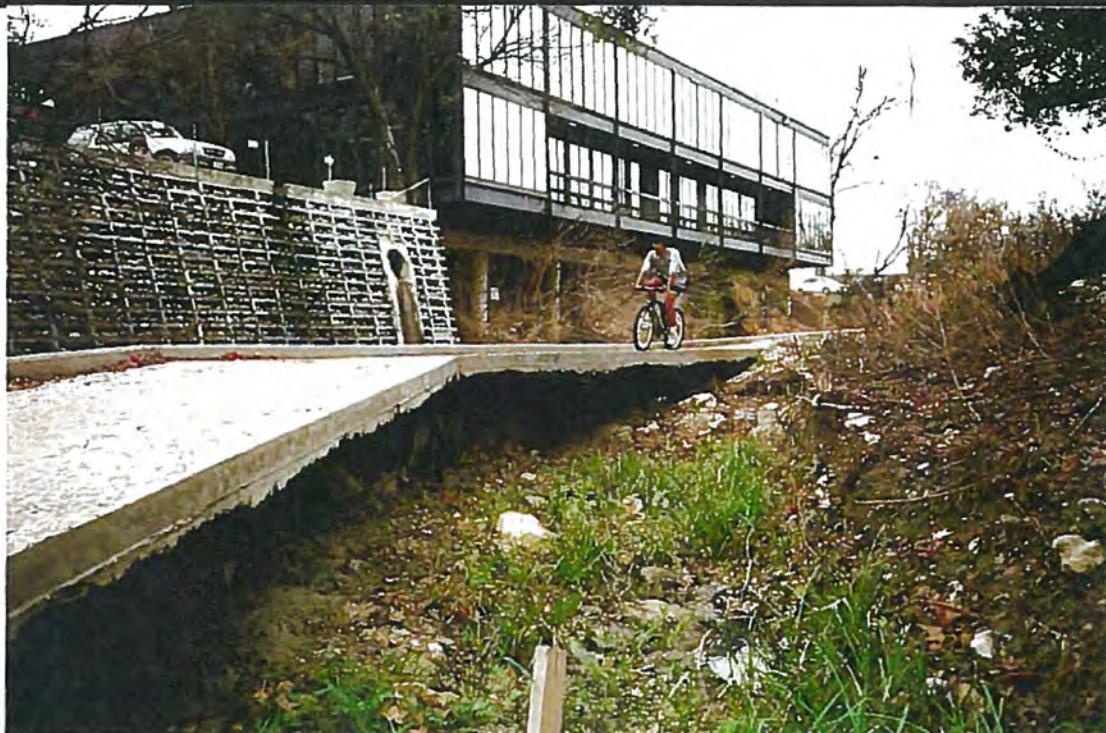
Photo 17. Washout behind hike & bike trail on left bank 200 feet U/S of 6th Street bridge looking D/S; notice crib wall across creek on outside of bend.

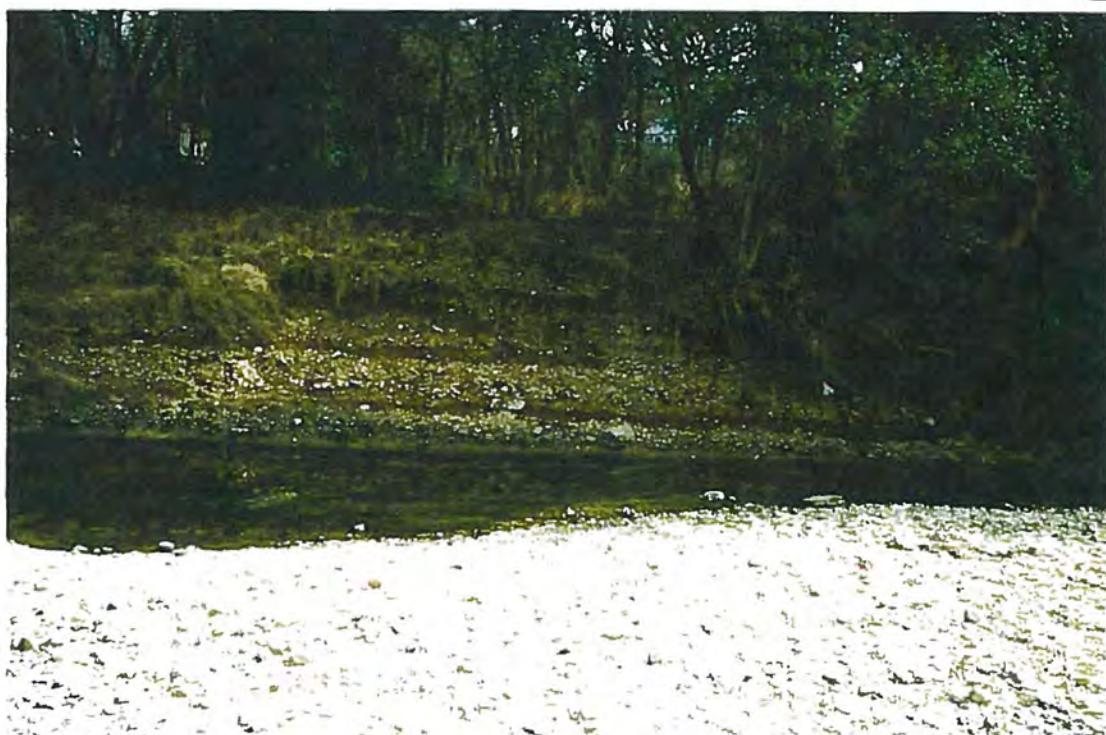
Photo 18. Approximately 200 feet D/S of West 9th Street; right bank with exposed roots; alluvial layers.

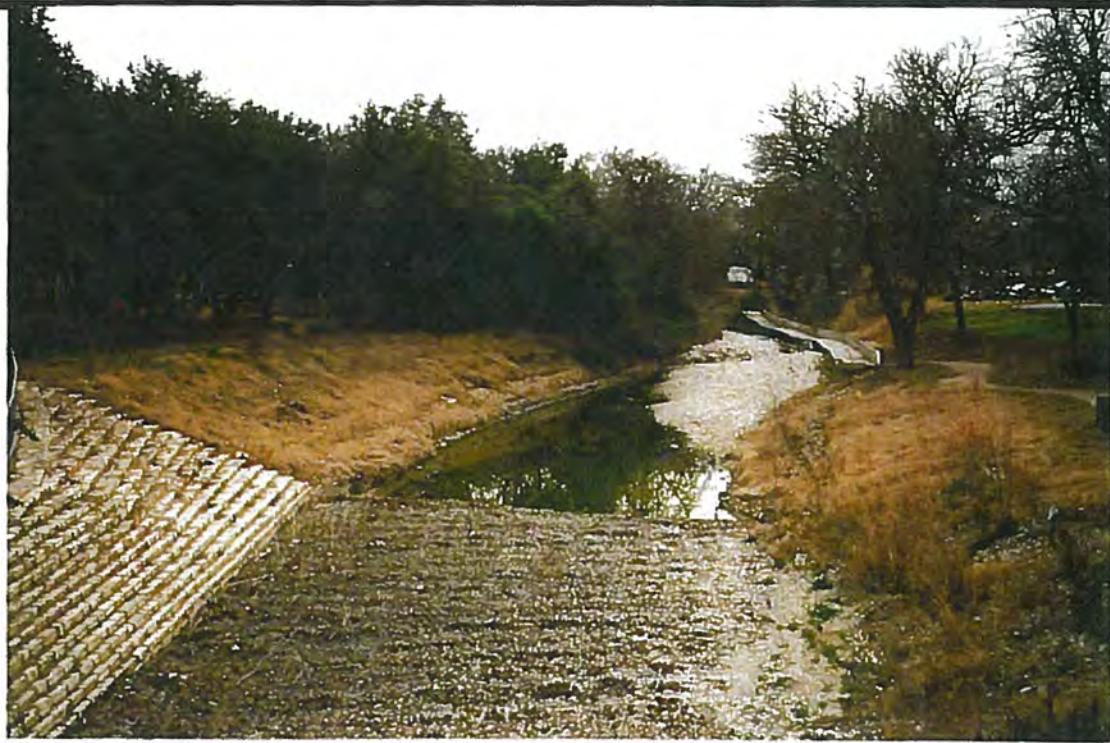
Photo 19. Gabion mattress in channel bed looking D/S from 9th Street bridge.

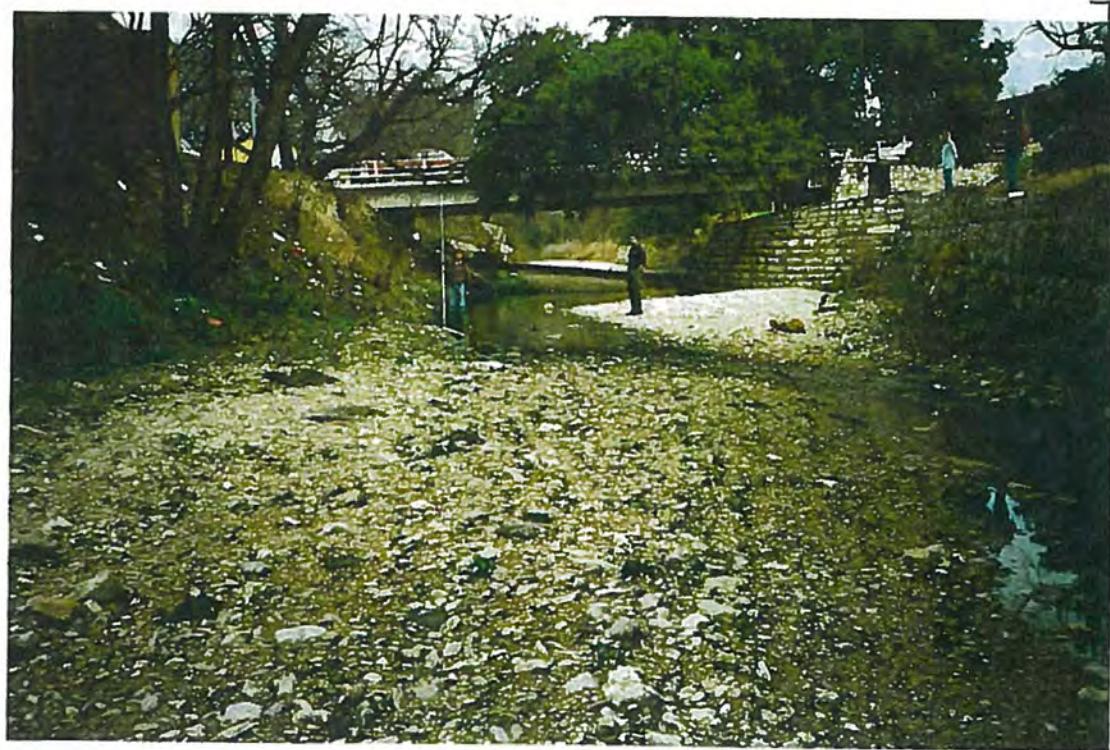
Photo 20. Looking U/S at 10th Street bridge; bankfull section 3-A.

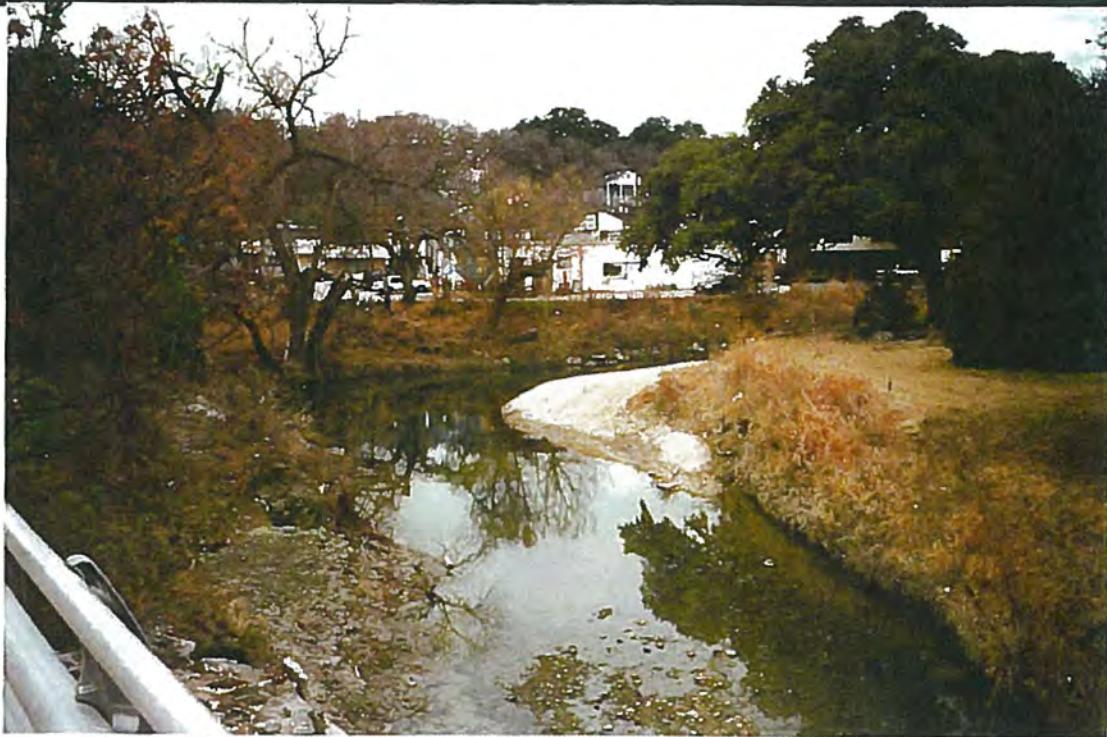
Photo 21. Point bar with avalanche face looking U/S from 9th Street.

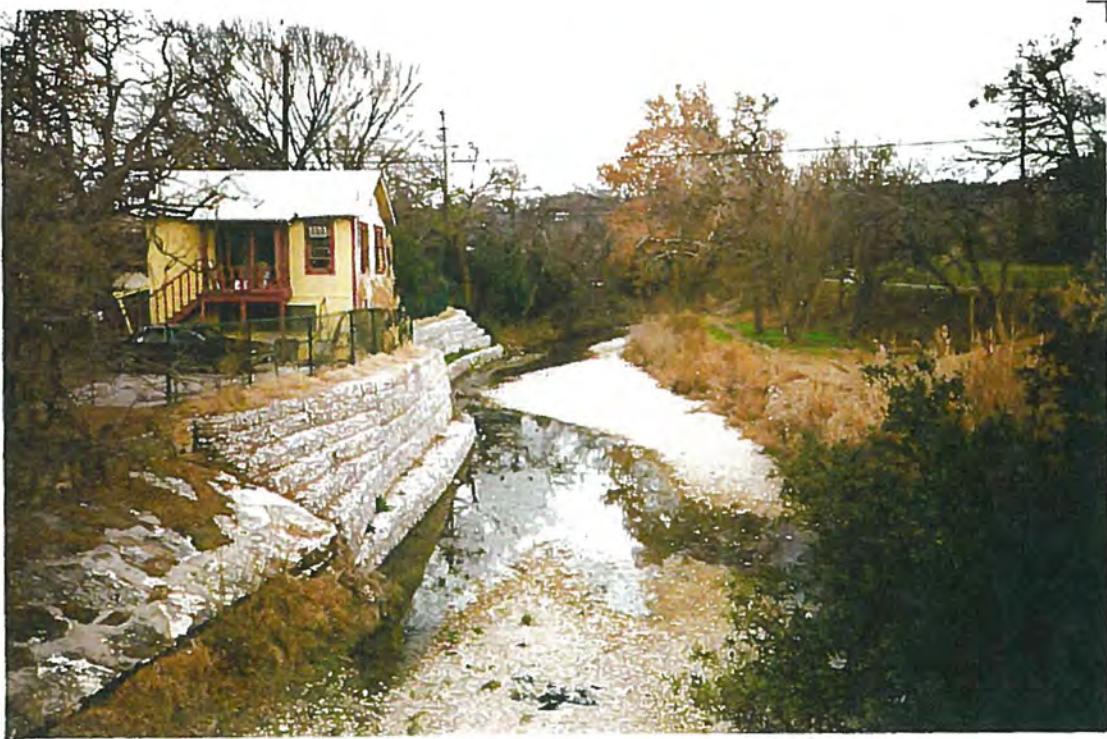
Photo 22. New gabions along west bank looking U/S from 10th Street bridge.

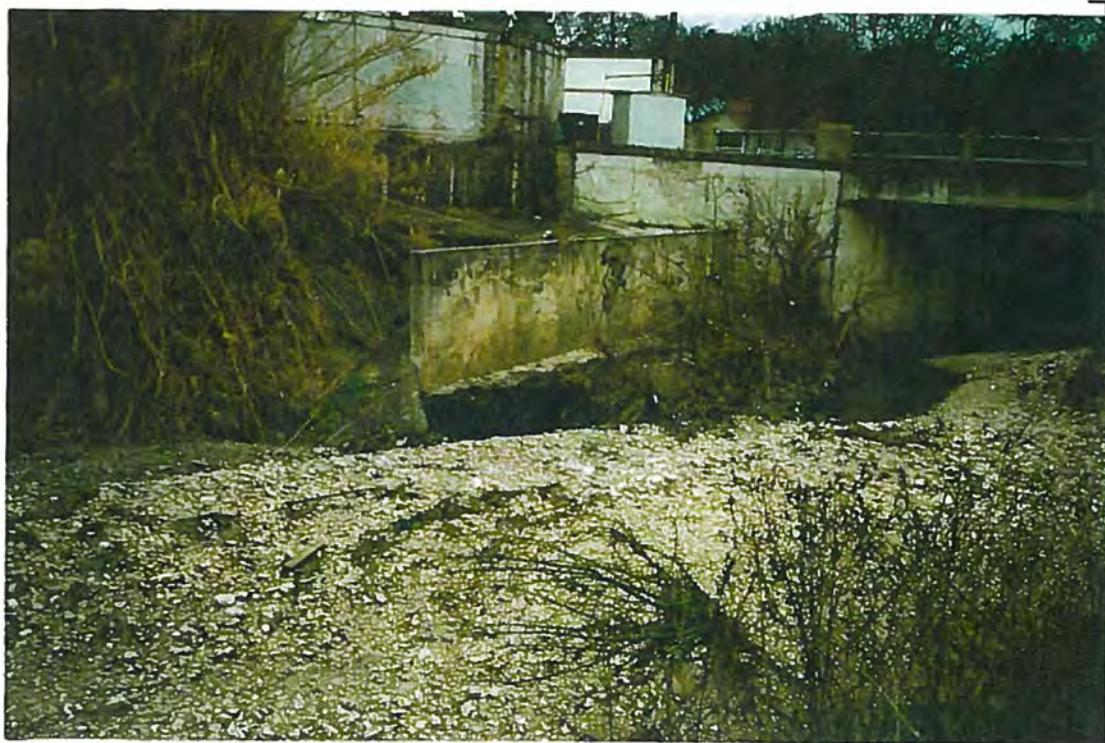
Photo 24. Left bank just downstream of Lamar Boulevard; type 2 erosion problem.

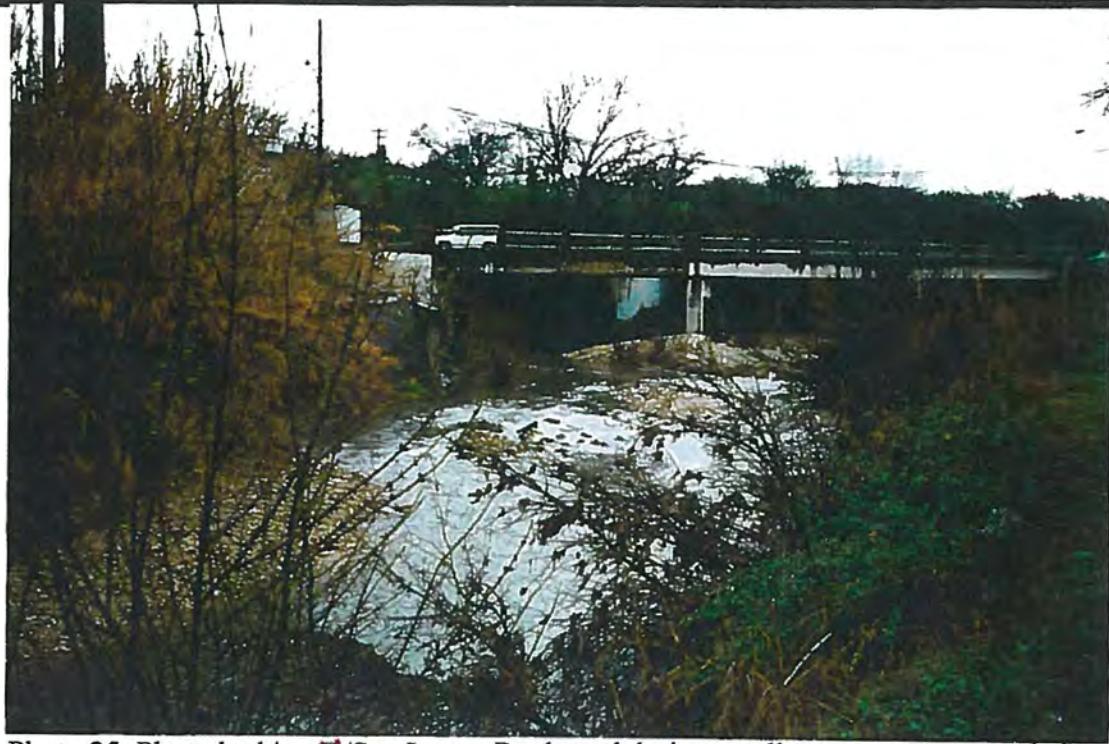
Photo 25. Photo looking U/S at Lamar Boulevard during small storm event; aggradation at Lamar bridge.
