# RESTORATION STUDY | 1887 WEST SIXTH STREET BRIDGE AT SHOAL CREEK

**SPARKS ENGINEERING, INC.**  
[www.sparksengineering.com](http://www.sparksengineering.com)

LIMBACHER & GODFREY  
ARCHITECTS

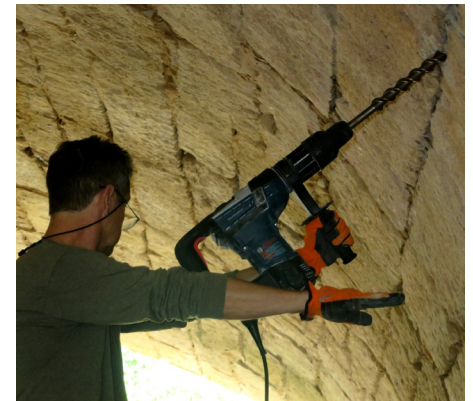
The backing<sup>1</sup> and fill<sup>2</sup> conditions (vital as a component to the structural system) discovered over the course of the study are depicted to the left.

*SEI drilling through an arch stone mortar joint to determine the amount of backing present within the bridge.*

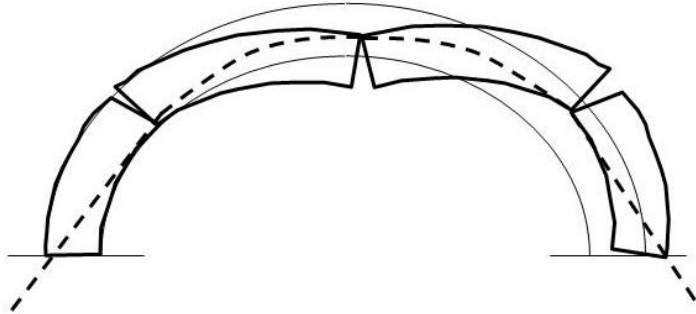
Masonry arches are intrinsically strong. The stresses are always low compared to the natural strength of the stone, and localized weaknesses in the material do not have a large effect on the structural capacity. It is the stability of the arch ring, either locally or globally, under concentrated load that determines capacity. The stability of a masonry arch bridge is governed entirely by its geometric proportions, principally the rise-to-span ratio, the depth of the arch ring, and the amount of overburden or fill (see backing and fill conditions diagram) above the arch crown.

*Typical arch collapse mechanism - formation of hinges.*

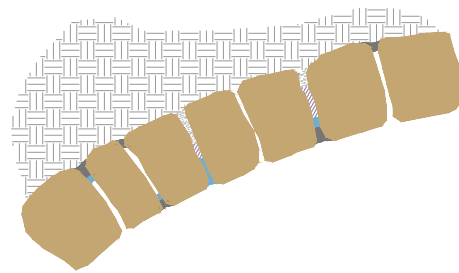
Mortar Loss

- Severe loss of mortar from the barrel vaults.
- Several crushed or cracked arch stones.
- Slippage of arch stones.
- One missing arch stone in vault C.
- Collapsed drainage tunnel, vault A.
- Telecom utility line cut into tops of vaults.
- Extensive root intrusion into the mortar joints of the bridge.
- Two historic construction joints in each vault.
- Instability of the north wing walls.
- Water infiltration.
- Concrete encasement around piers in good condition, although fully carbonated.
- Good condition of the spandrel walls.

The capacity of masonry arches is largely insensitive to the material strength of the stone, but is highly sensitive to the condition of the mortar, which if missing or loose allows movement. Other factors affecting the load capacity include: the presence of arch distortions and discontinuities, the depth and quality of the fill material, and the presence of 'backing' masonry between adjacent arch rings. The condition assessment of the West Sixth Street Bridge focuses on these key factors.

Repointing and grouting all mortar joints is critical to recovering the structural integrity of the bridge.
